<u>Modified Phase I and Phase II Environmental Site</u> <u>Assessment (ESA)</u>

US97: J St. Intersection (Madras South Y) Sec. The Dalles-California Highway, M.P. 92.78 to M.P. 96.30 Madras, Jefferson County

Key#: 15409

August 1, 2012

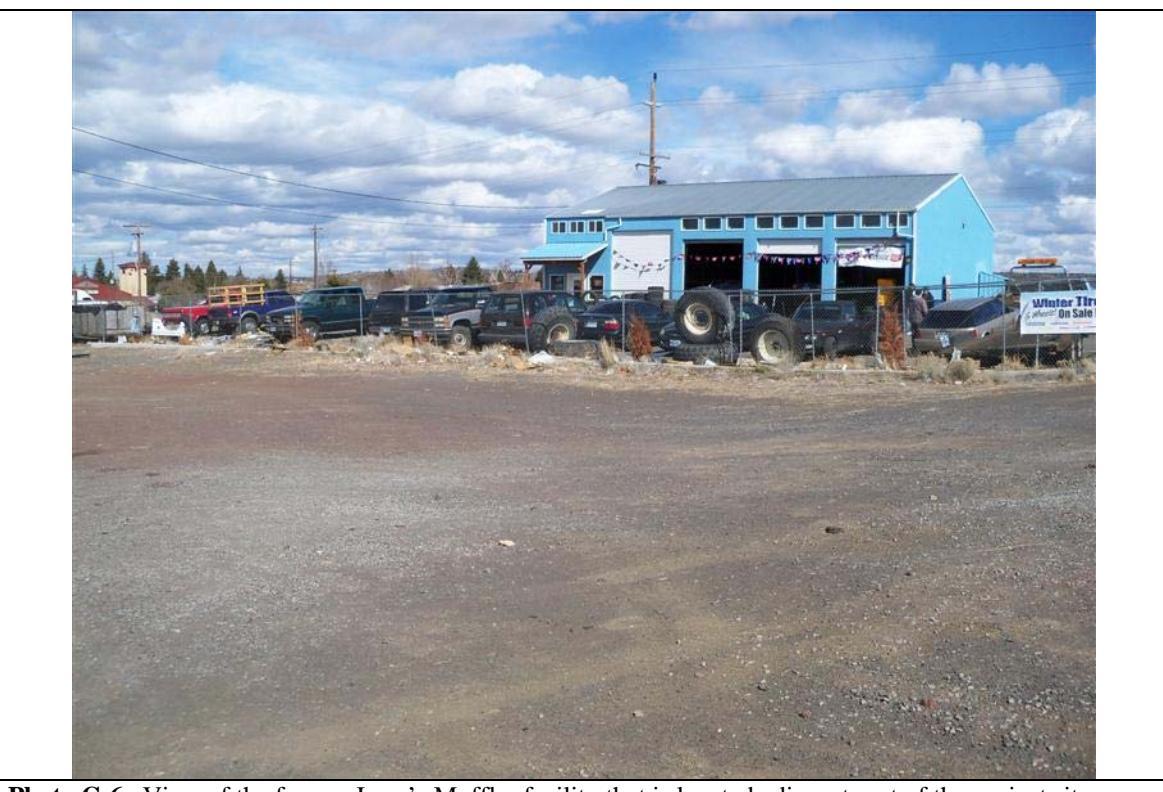
Surface motor oil stains are suspected at the former Jerry's Muffler facility where several vehicles are frequently parked along the west property line with the project site (Photo C-6). Due to wet soil conditions during the project site reconnaissance, oil stains were difficult to identify.

Photo C-6. View of the former Jerry's Muffler facility that is located adjacent east of the project site. Photo taken facing northeast.

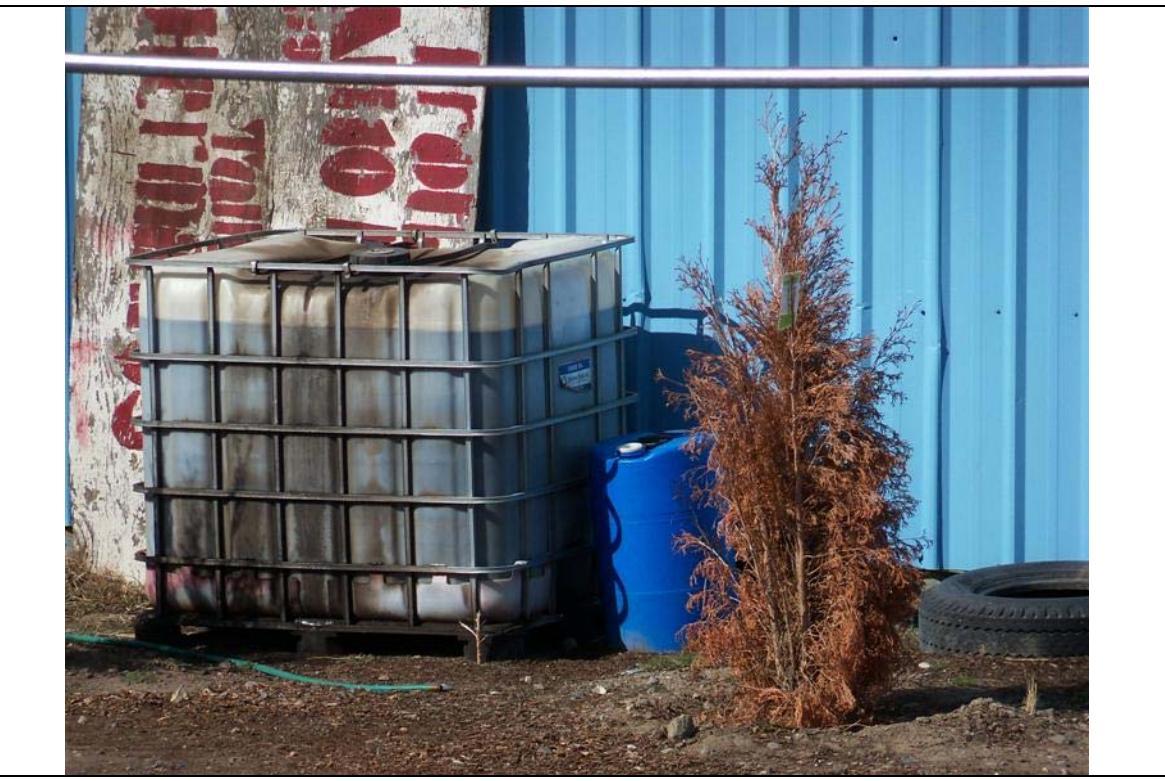
An above-ground poly storage tank that apparently contained waste oil was observed on the former Jerry's Muffler property located adjacent east of the project site (Photo C-7). The outside of the AST appeared to be stained with oil and a wood pallet under the AST also appeared to be oil-stained. Soil contamination beneath the AST is suspected based on the staining observed on the outside of the AST. This AST is not considered to pose a risk to the project because it is located 80 ft from the project site and the quantity of released oil appears to be small.

Stressed vegetation was observed at the former Jerry's Muffler facility. Dead arborvitae trees were observed adjacent to the AST (Photo C-7) and along the east and west sides of this property. It is not known whether contaminants or lack of water caused the death of these trees.

Photo C-7. View of the apparent waste oil AST located on the south side of the former Jerry's Muffler building. Note the dead arborvitae tree. Photo taken facing north.

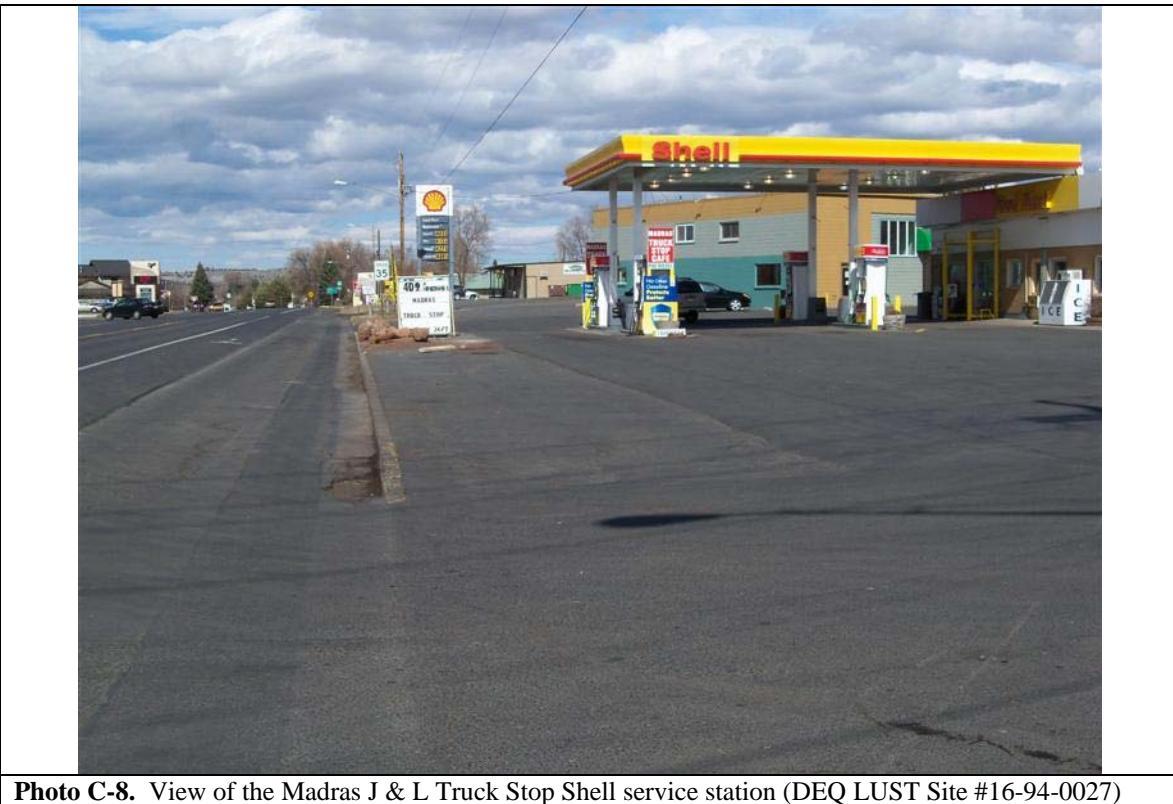
USTs were observed at the active Shell service station (Madras J and L Truck Stop) located 0.07 miles south of the project site (Photo C-8). This facility is discussed in Sections 4.2.4 and 4.2.5.

Photo C-8. View of the Madras J & L Truck Stop Shell service station (DEQ LUST Site #16-94-0027) located 0.07 miles south of the project site. Photo taken facing northeast.

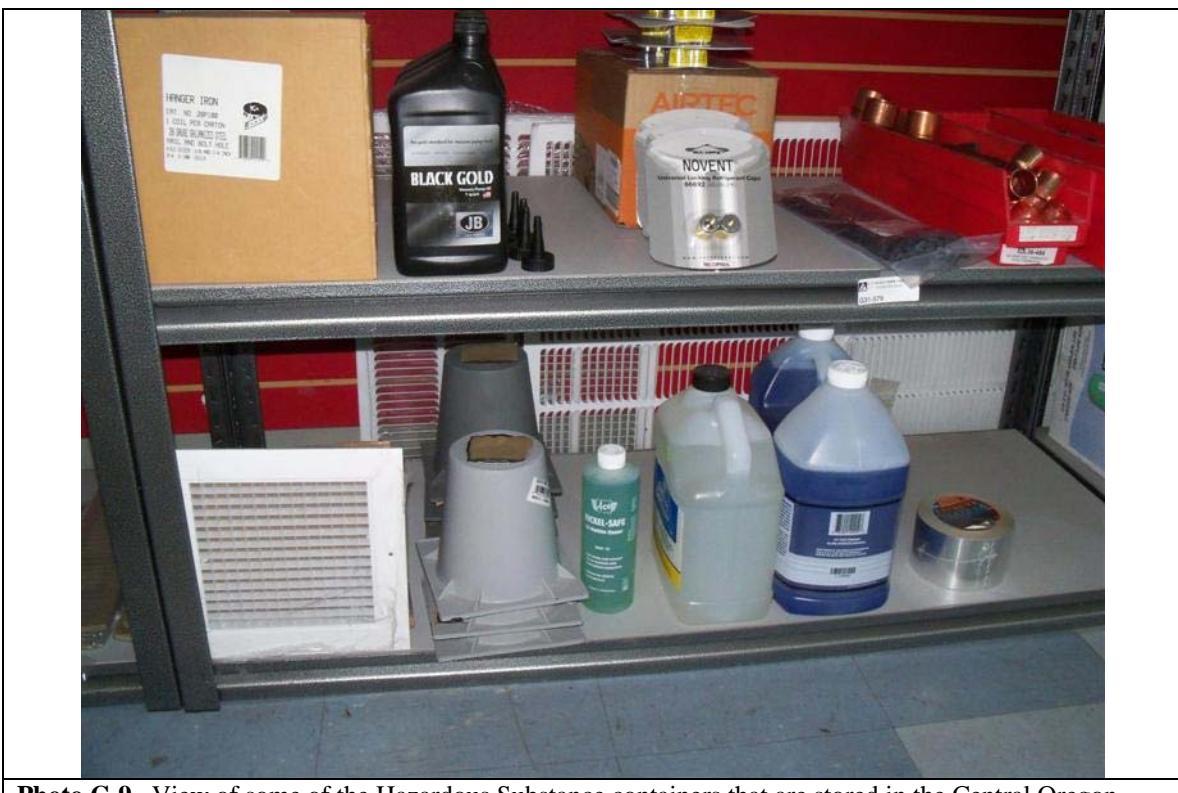
Hazardous substance containers designed for consumer end use were observed in the portion of the commercial building that is occupied by Central Oregon Heating and Cooling (Photos C-9 and C-10). Examples of hazardous substances observed included pipe thread sealant, vacuum pump oil, and coil cleaner. All of these substances were stored in their original containers on sturdy shelves. The storage area was clean and

Photo C-9. View of some of the Hazardous Substance containers that are stored in the Central Oregon Heating and Cooling facility located on the project site. Photo taken facing south.

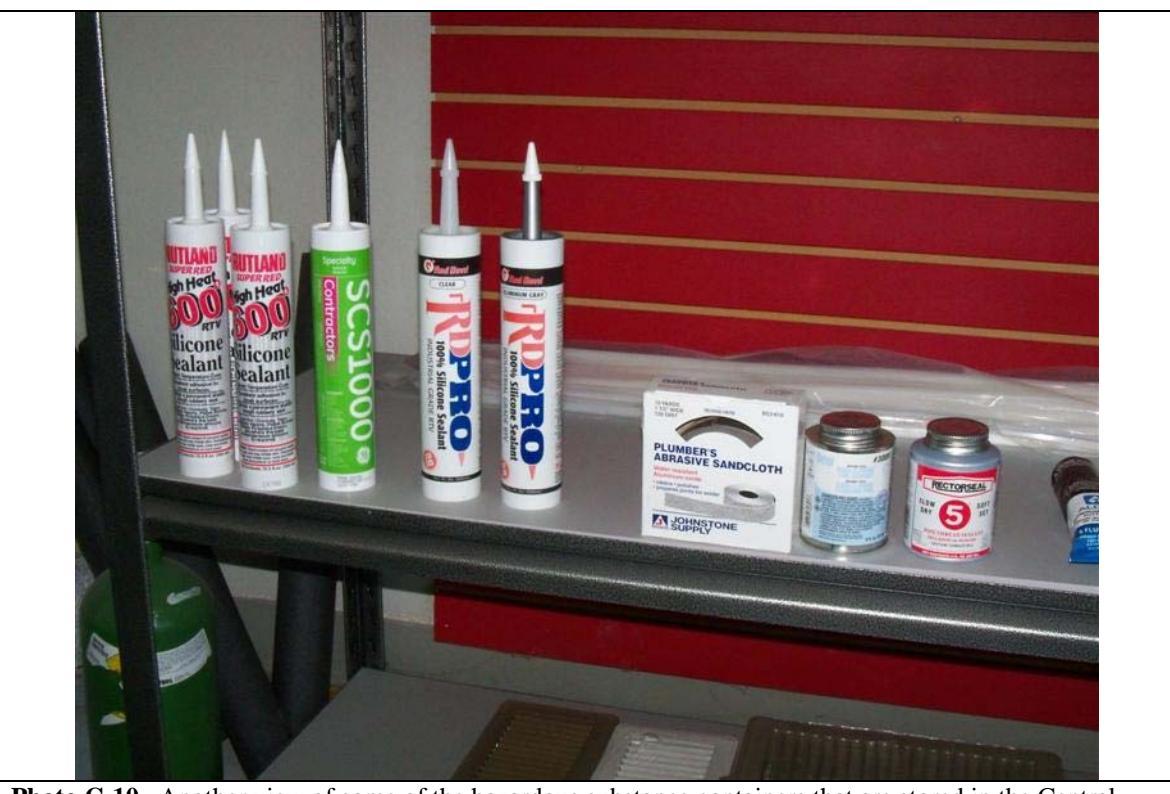
Photo C-10. Another view of some of the hazardous substance containers that are stored in the Central Oregon Heating and Cooling facility located on the project site. Photo taken facing south.

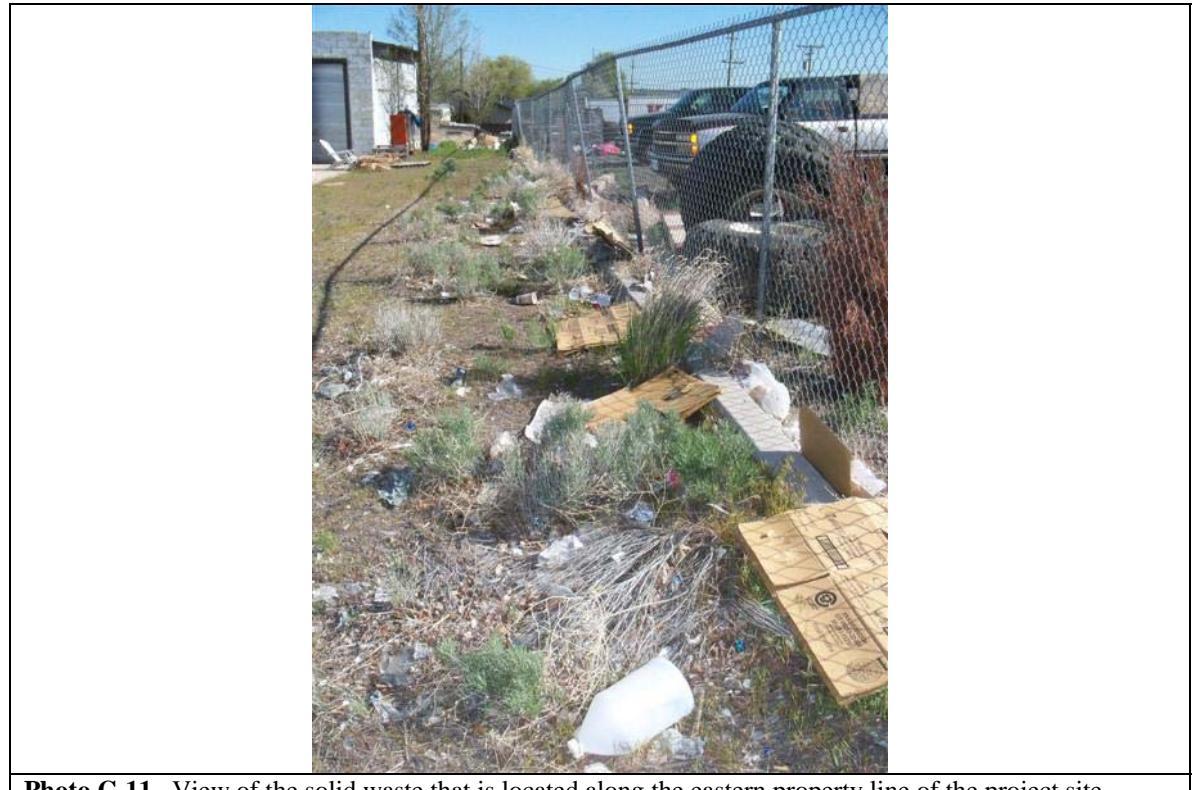
Solid waste was observed at the project site along the eastern property line (Photos C-11 to C-13). Most of this material was debris consisting of cardboard and plastic containers and other light materials that were apparently blown by wind into the property line fence. Miscellaneous automobile parts, tires, cardboard, and plastic materials were observed on the east side of the fence on the former Jerry's Muffler property.

Photo C-11. View of the solid waste that is located along the eastern property line of the project site. Photo taken facing north.

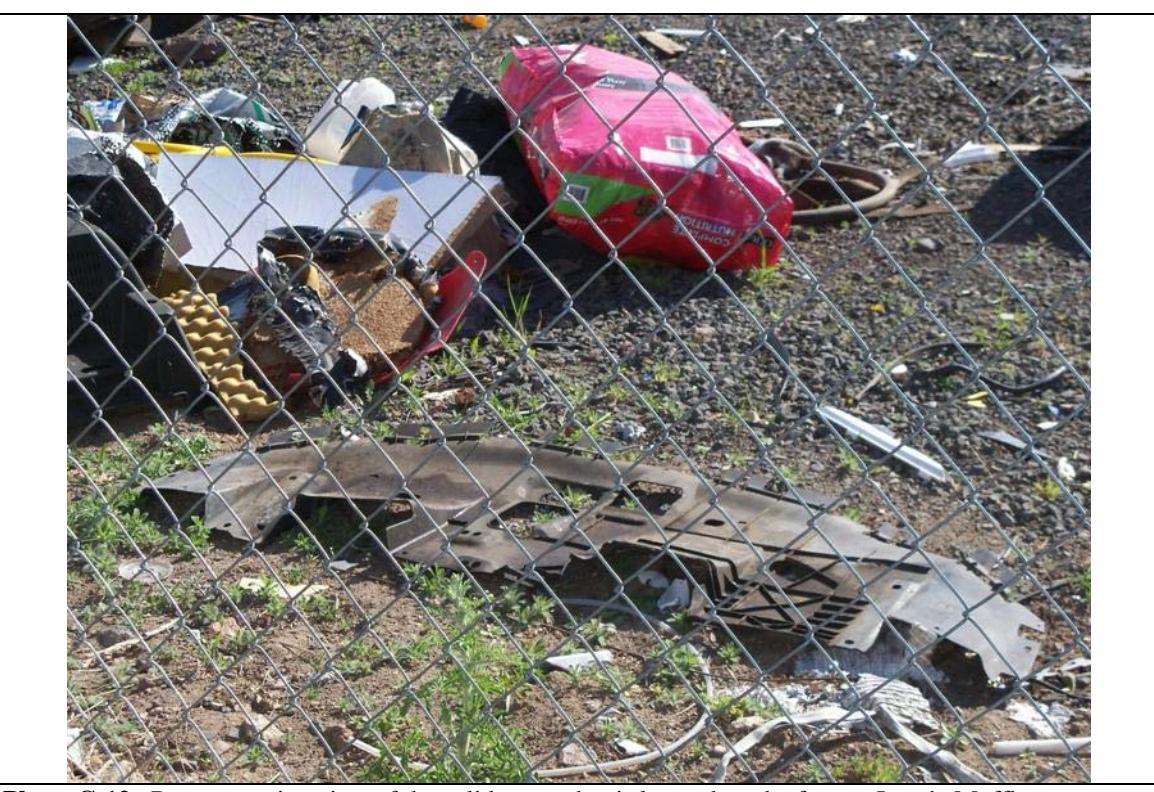
Photo C-12. Representative view of the solid waste that is located on the former Jerry's Muffler property along the eastern property line of the project site. Photo taken facing northeast.

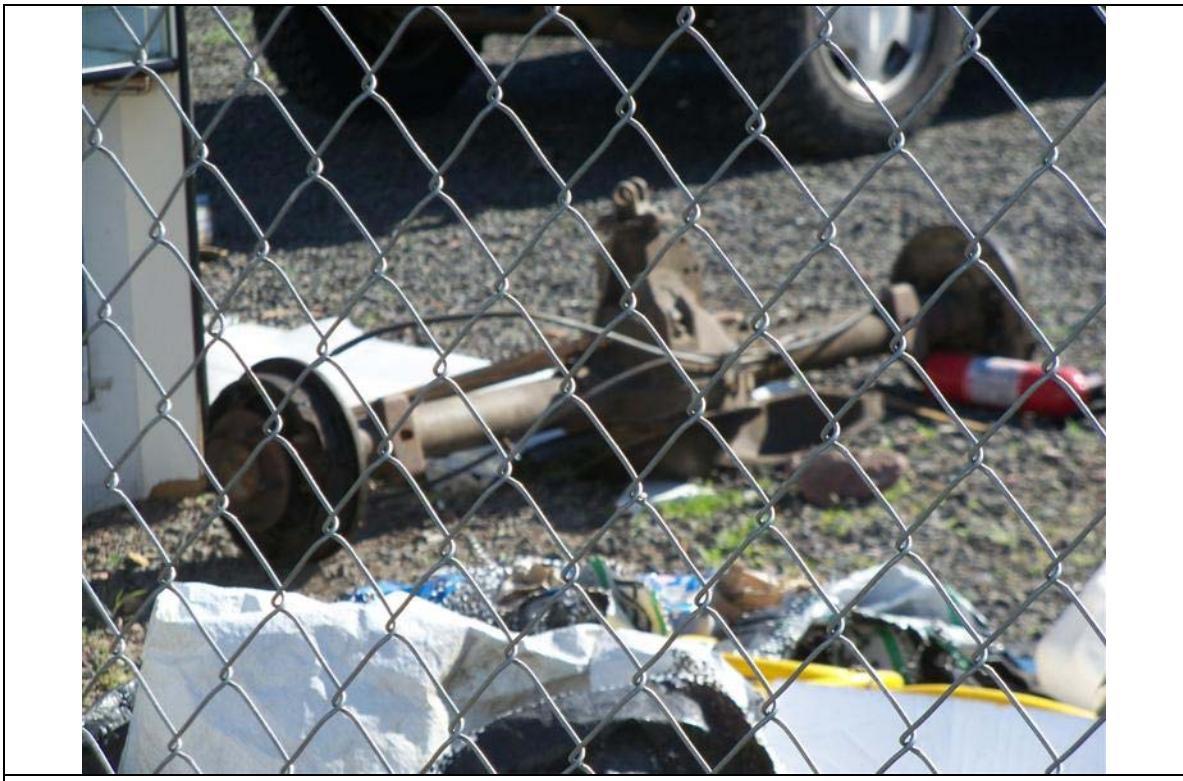
Photo C-13. Another representative view of the solid waste that is located on the former Jerry's Muffler property along the eastern property line of the project site. Photo taken facing northeast.

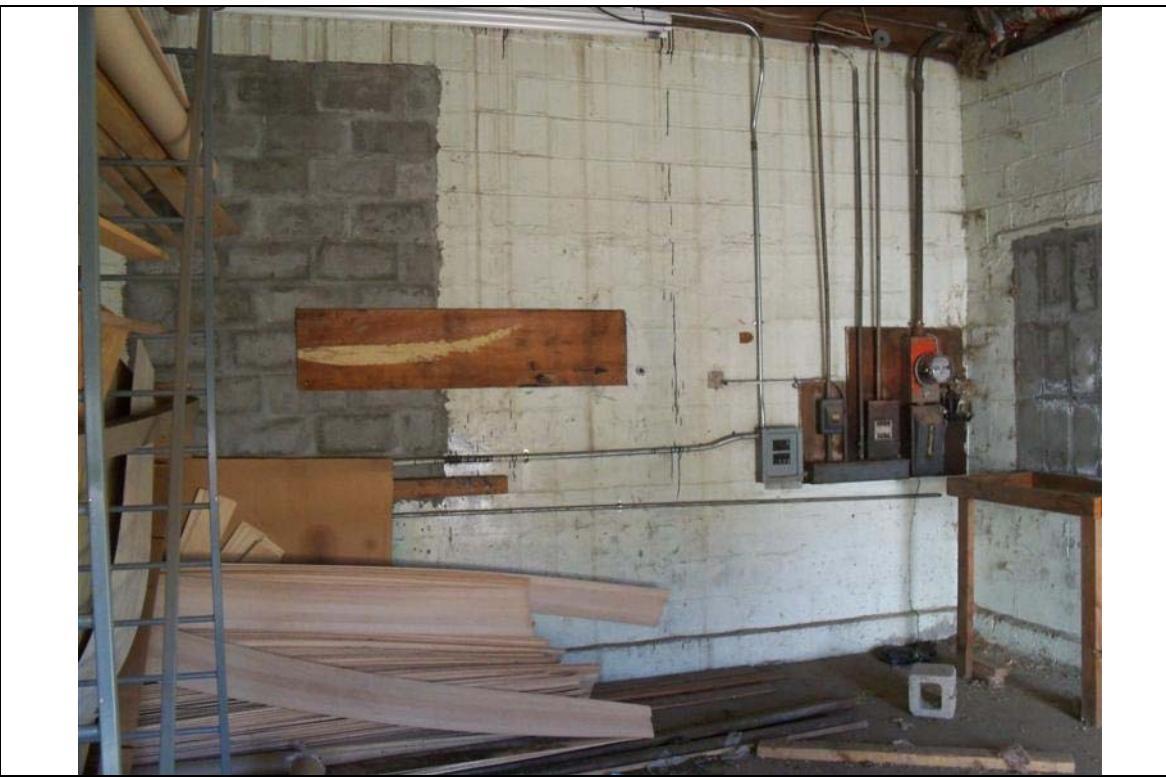
Old electrical panels and meters were observed in the shop building that may contain asbestos (Photos C-14 to C-17). No other suspected asbestos-containing materials were observed. ODOT Region 4 Right of Way (R4 R/W) will have an asbestos survey performed on all structures prior to demolition of the buildings.

Photo C-14. View of the east bay of the shop building located on the project site. Note the circuit breaker, electrical switches and meter located center right. Photo taken facing northeast.

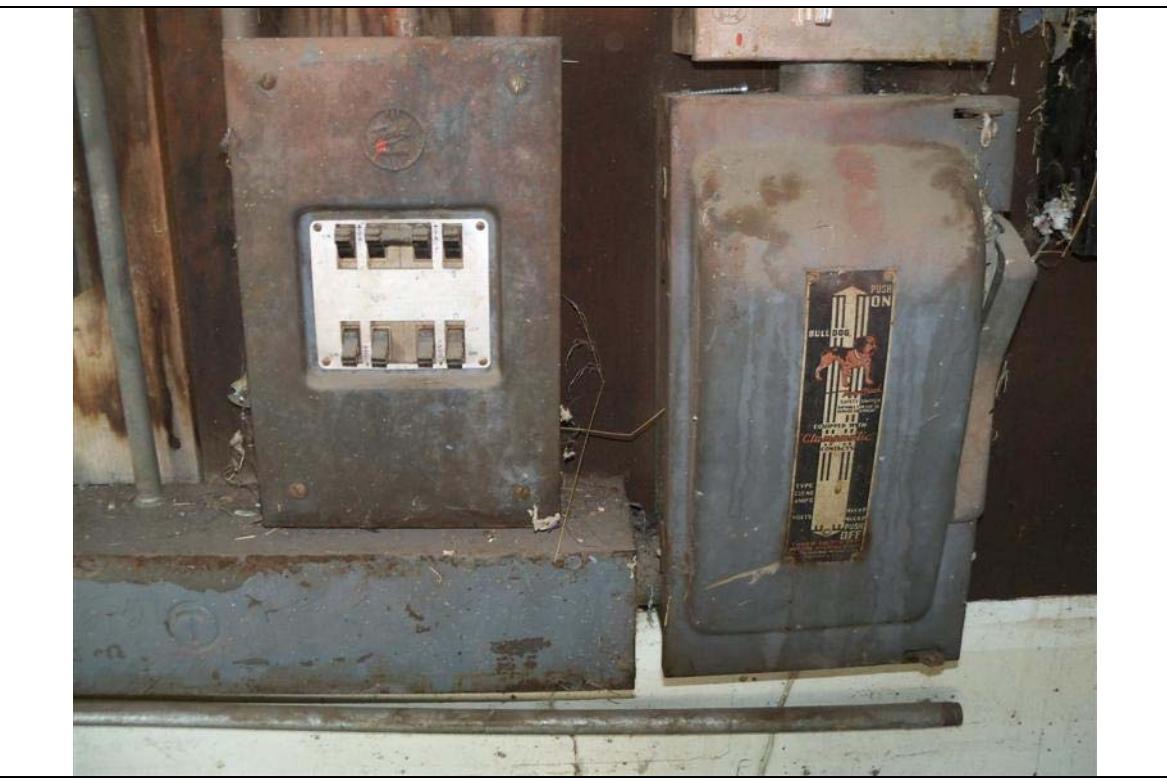
Photo C-15. Close up view of one of the circuit breakers and electrical switches shown in Photo C-13. Photo taken facing northeast.

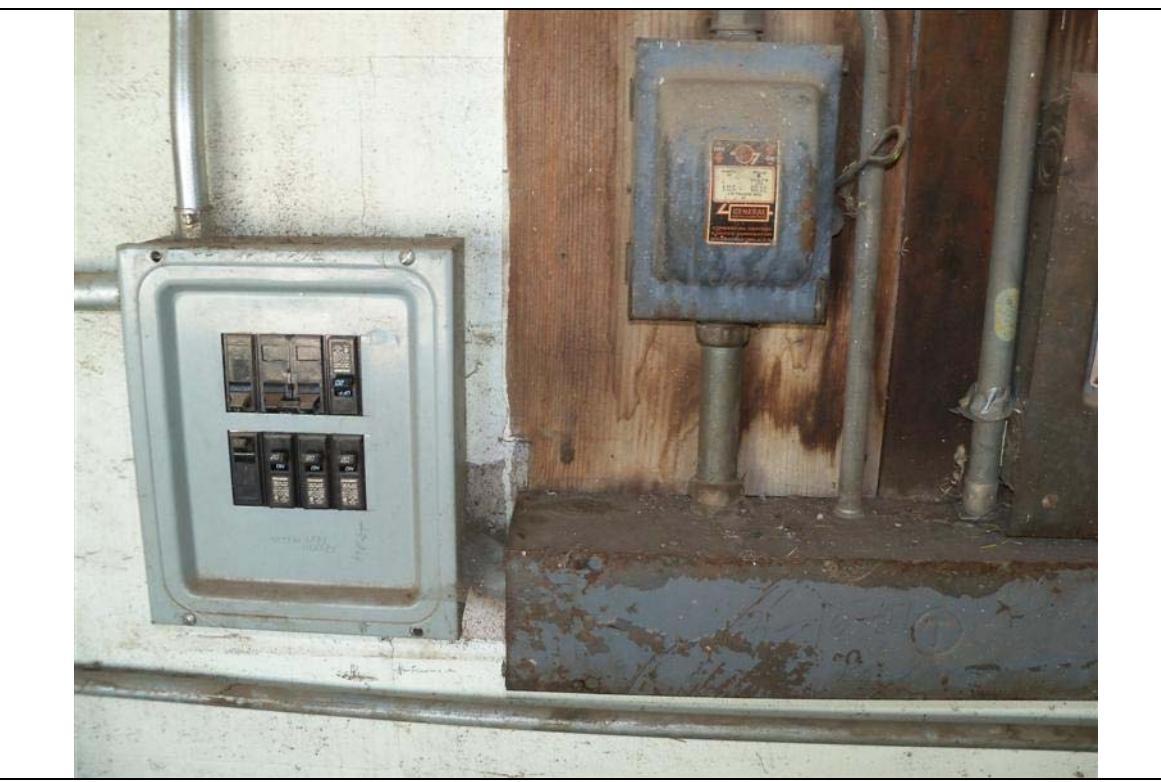
Photo C-16. Close up view of another circuit breaker and electrical switch shown in Photo C-13. Photo taken facing northeast.

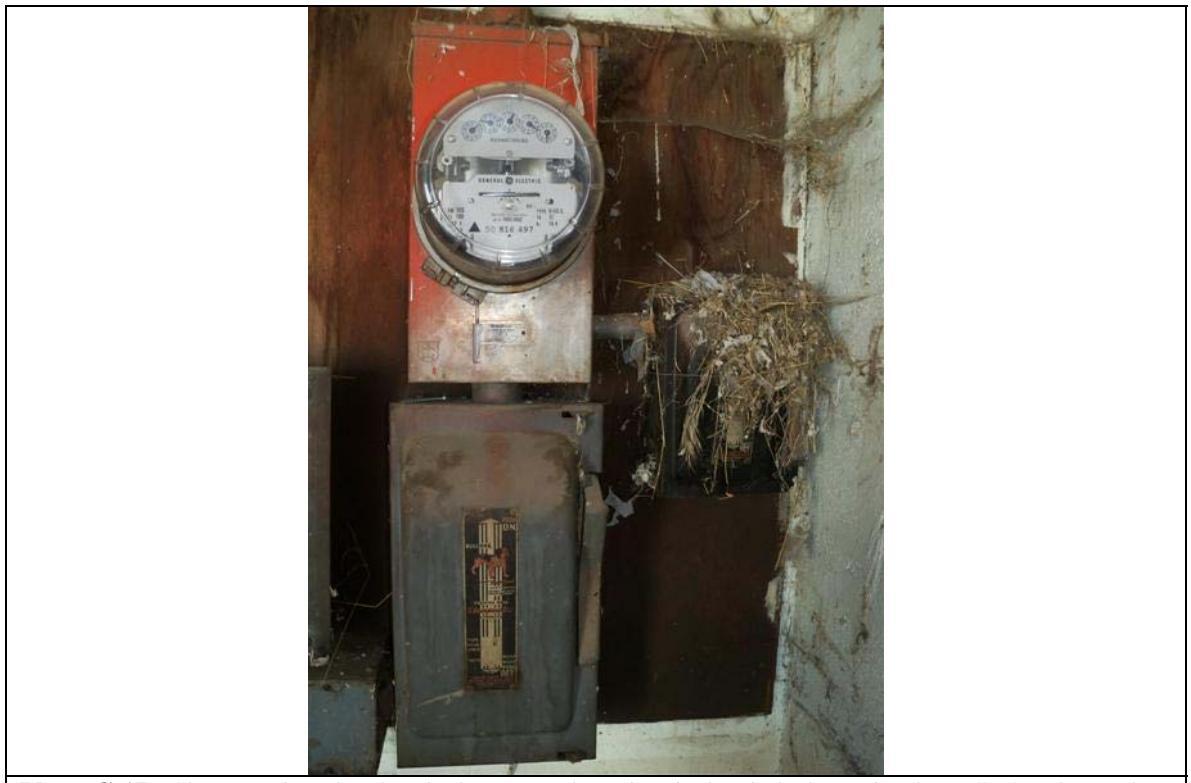
Photo C-17. Close up view the electrical meter and an electrical switch shown in Photo C-13. Photo taken facing northeast.

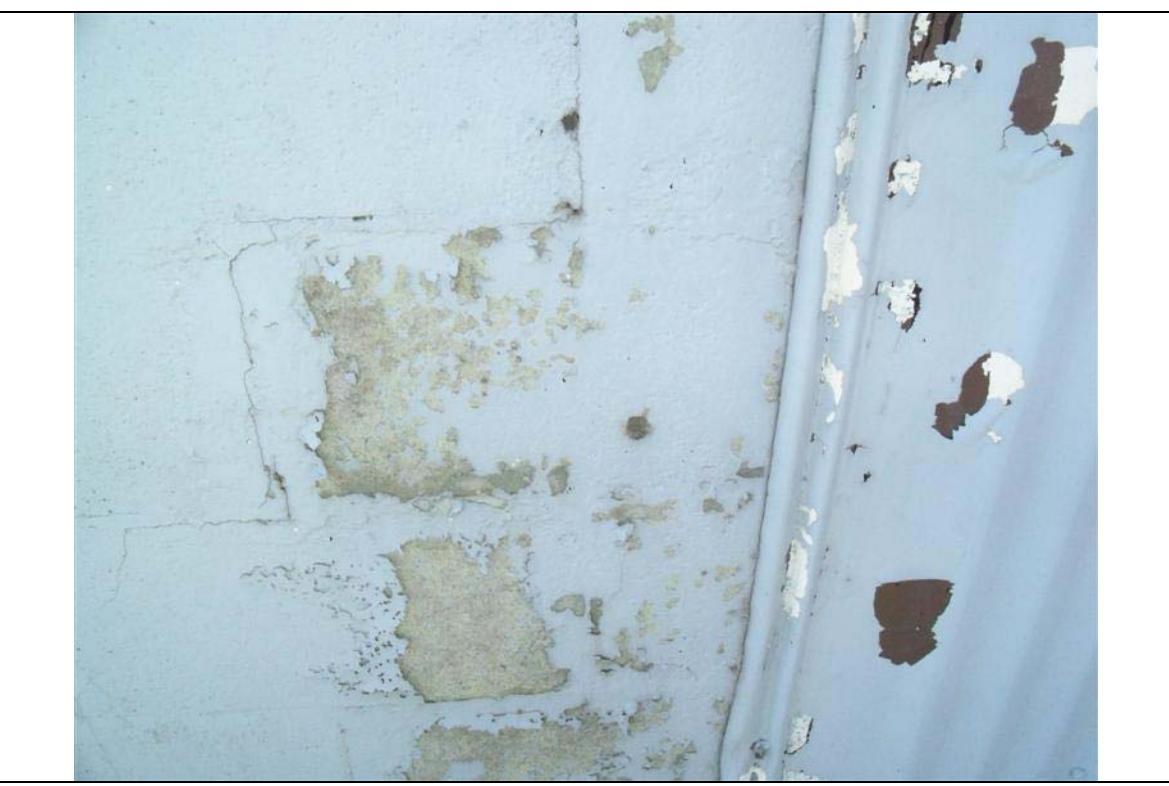
Peeling/damaged paint was observed on the exterior of the shop building (Photo C-18). Since this building was constructed prior to 1978, it is suspected that this paint contains lead. ODOT Region 4 Right-of-Way (R4 R/W) will have a lead-based paint survey conducted prior to demolition.

Photo C-18. Representative view of the suspected lead-based paint on the shop building located on the project site. Photo taken facing west.

- The ODOT Right-of-Way unit will address the florescent/HID lamps and ballasts, PCBs, asbestos, and lead-based paint issues as part of the building demolition contract.

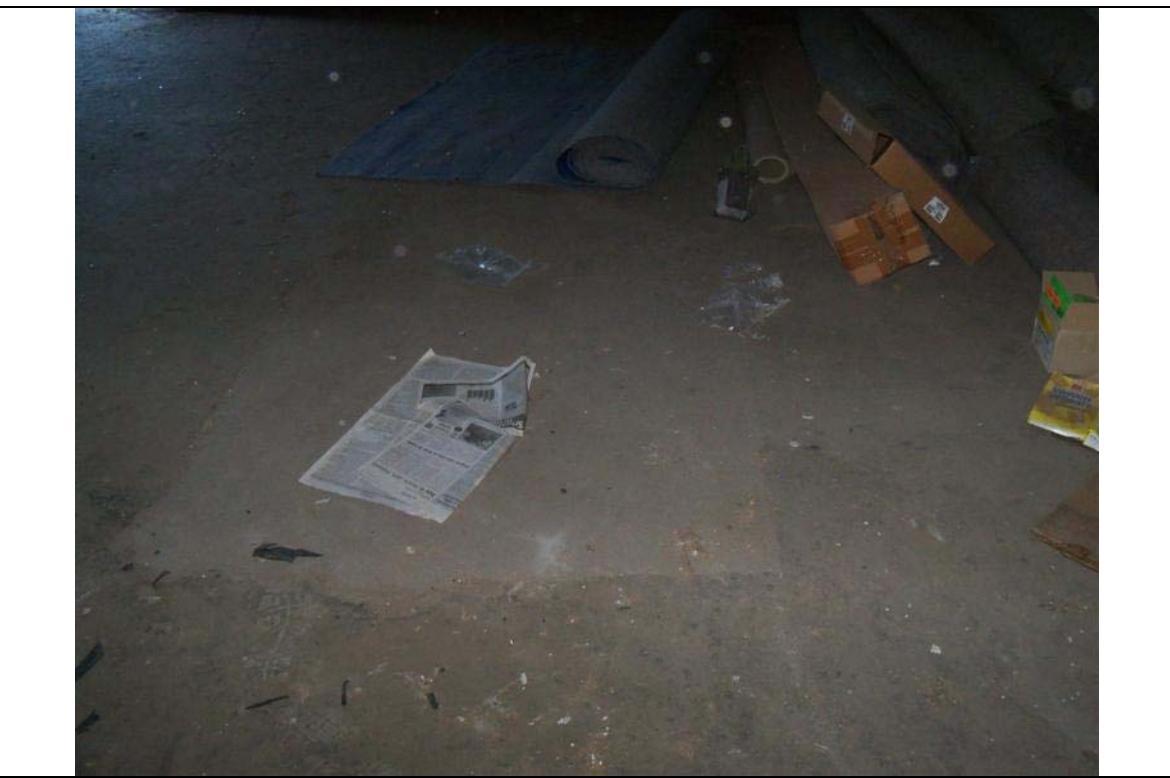
An apparent former hydraulic lift pit was observed in the west bay of the shop building (Photo C-19). The evidence for the hydraulic lift includes a square concrete patch measuring approximately three by three feet with a linear concrete patch measuring approximately six inches wide leading from the square patch to the west wall. Releases of hydraulic fluid that may contain PCBs were suspected to have occurred in the soils underneath the shop building (See Section 6.0).

Photo C-19. View of the square concrete patch in the west bay of the shop building where an apparent former hydraulic lift was removed. Photo taken facing south.

- The landowner should have the contaminated soil removed from the former hydraulic lift pit prior to ODOT acquisition of the property.
- If the landowner decides to not remove the contaminated soil, ODOT should have the construction contractor remove the contaminated soils during construction. The appraised value of the property should be adjusted to cover the costs that ODOT will incur to remove the contaminated soils. The estimated cost for removal and disposal of the contaminated soils is \$6,850.

- If the contaminated soil is removed during construction, special provisions will be required to address the excavation, handling, and disposal of the contaminated soil.

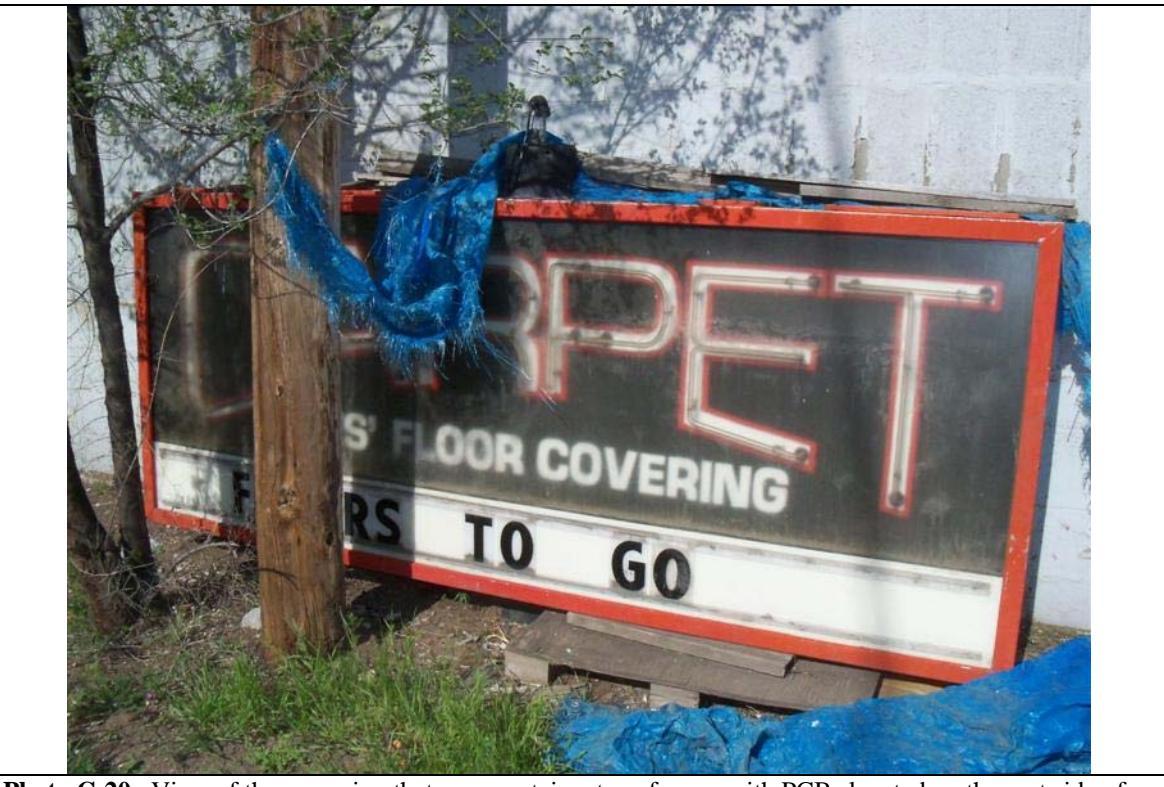
A neon sign that may have an internal transformer that contains PCBs was observed leaning up against the east side of the shop building (Photo C-20).

Photo C-20. View of the neon sign that may contain a transformer with PCBs located on the east side of the shop building on the project site. Photo taken facing west.

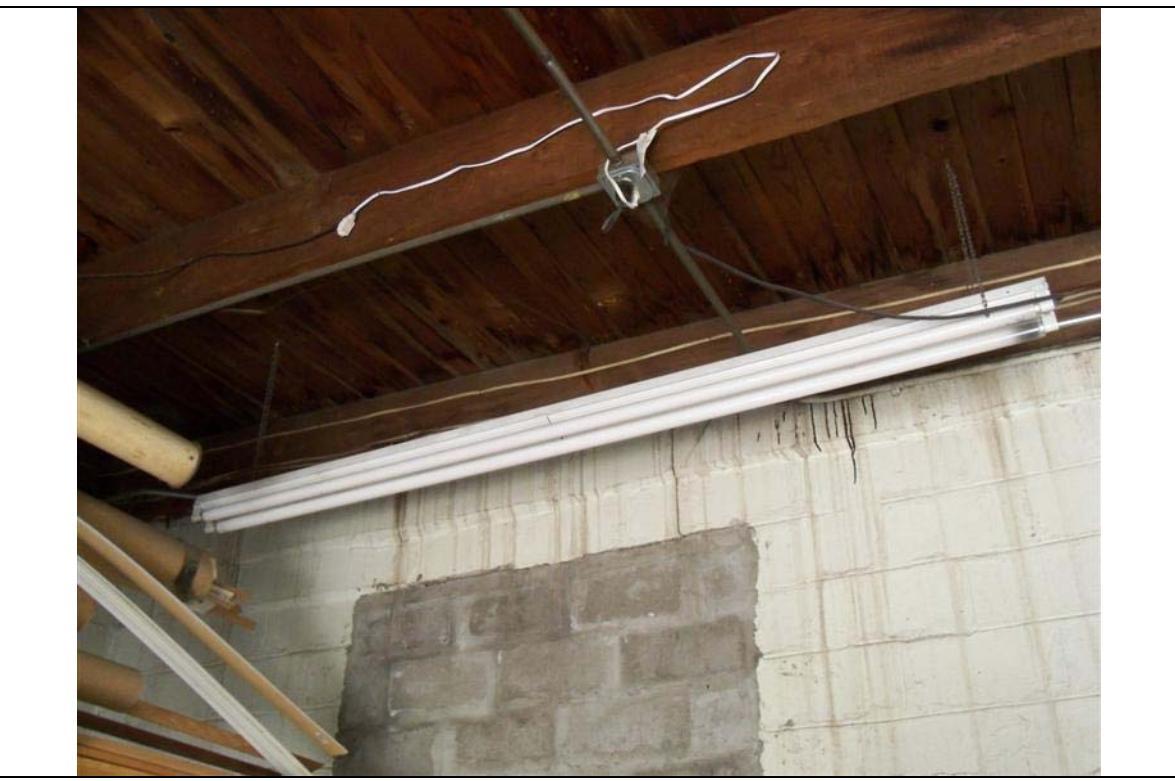
Florescent lights were observed inside the shop building and in both businesses in the commercial building (Photos C-21 and C-22). One high intensity discharge (HID) lamp was observed on the outside of the shop building (Photo C-23) and another HID lamp was observed on the treated utility pole that is located near the northwest corner of the project site (Photo C-24).

The florescent light ballasts that were observed in the commercial and shop buildings may contain polychlorinated biphenyls (PCBs).

Photo C-21. View of a fluorescent light fixture and bulbs in the shop building located on the project site. Photo taken facing east.

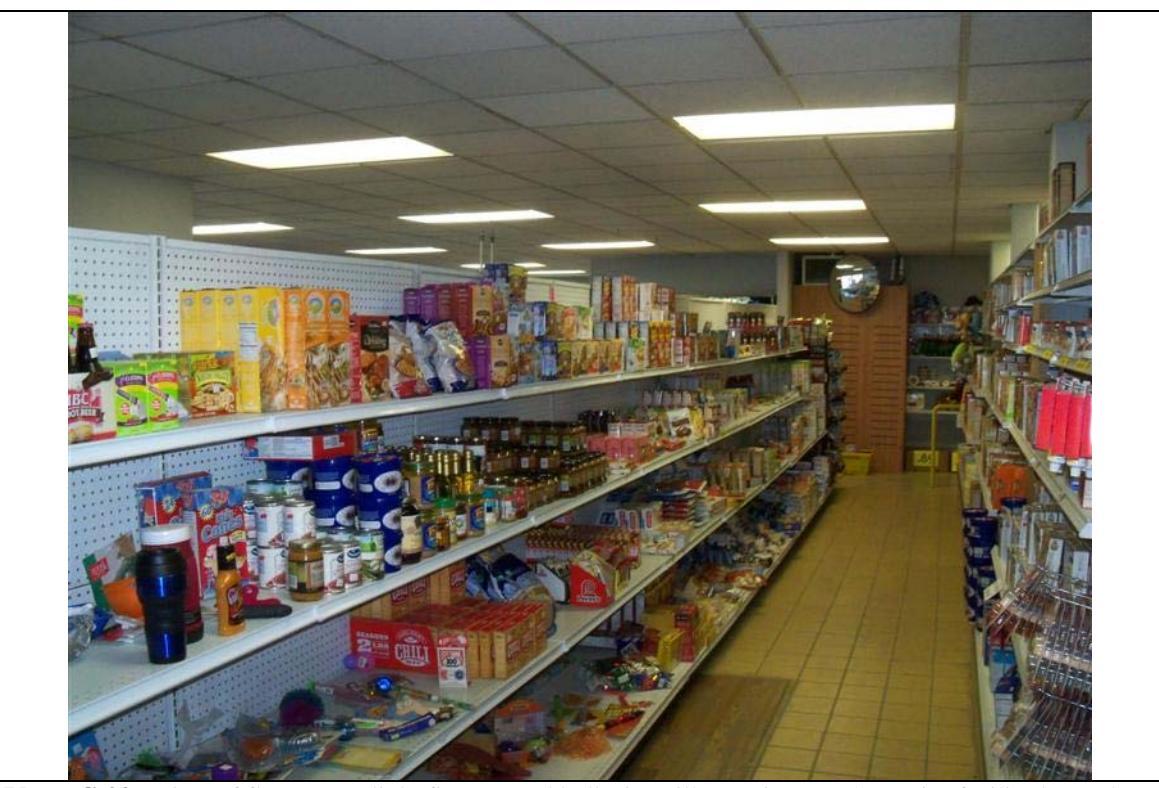
Photo C-22. View of fluorescent light fixtures and bulbs in Miller's Discount Groceries facility located on the project site. Photo taken facing south.

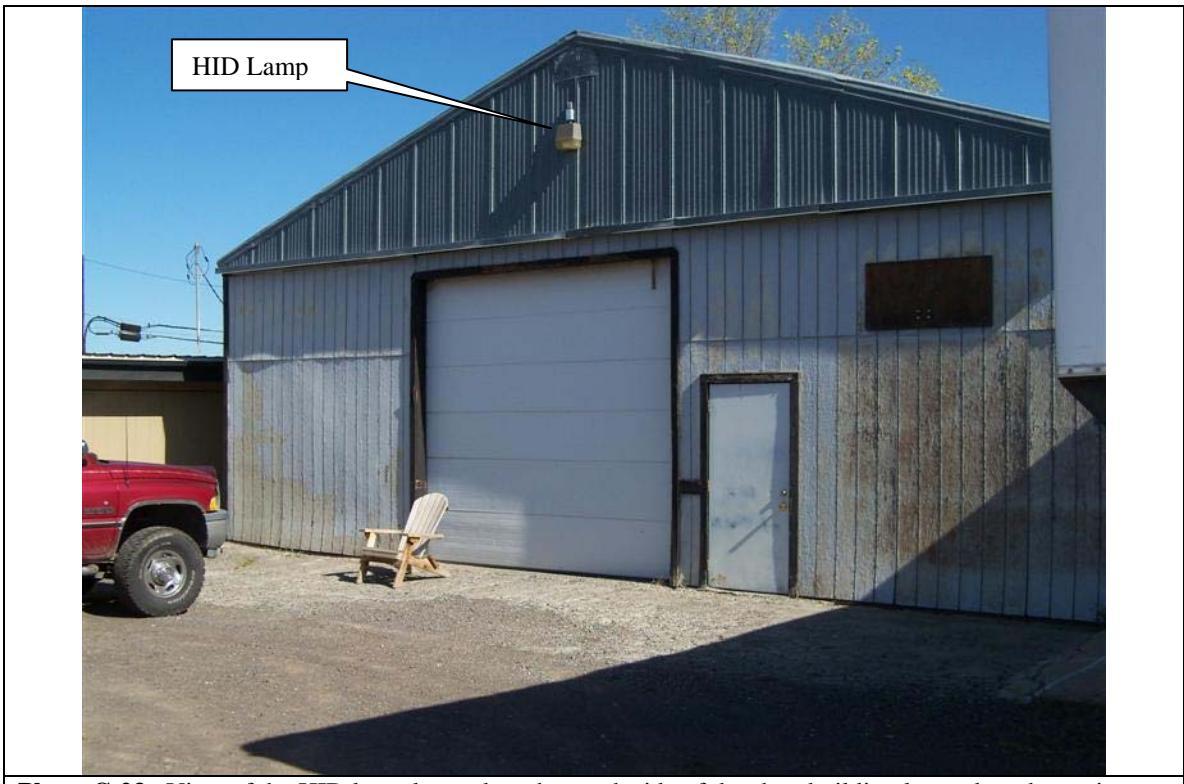
Photo C-23. View of the HID lamp located on the south side of the shop building located on the project site. Photo taken facing northwest.

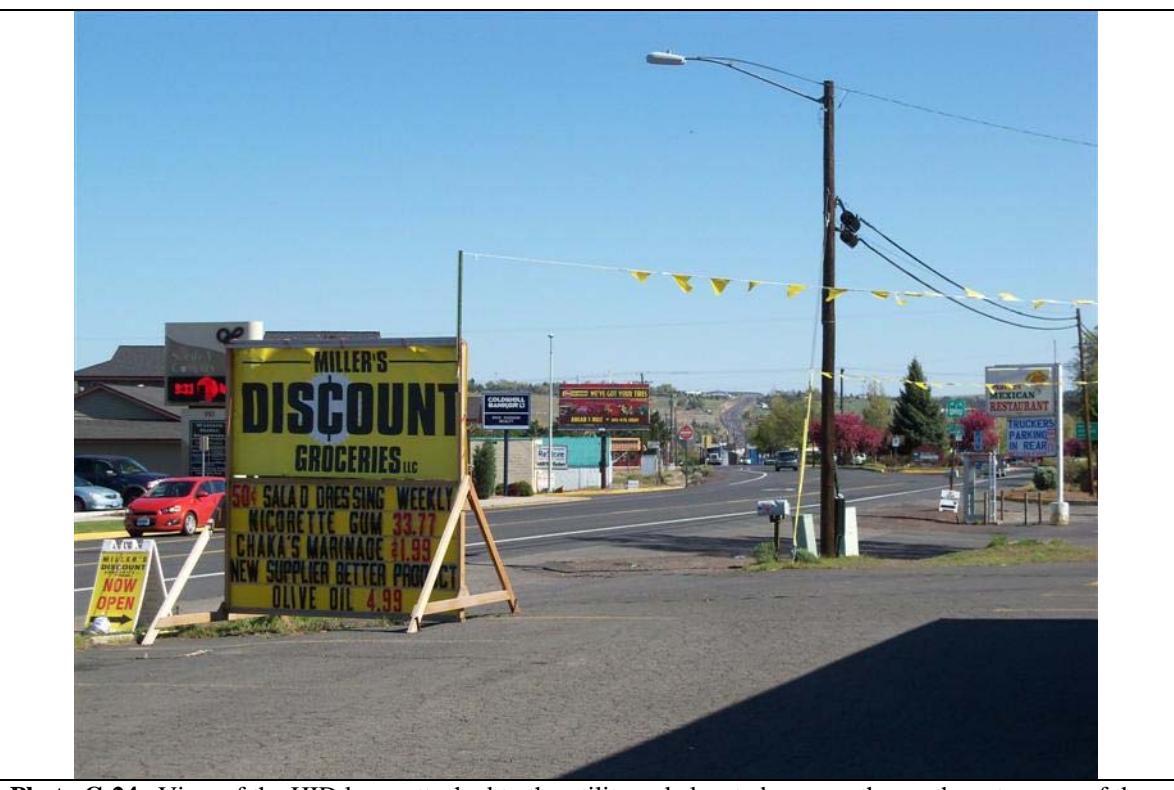
Photo C-24. View of the HID lamp attached to the utility pole located on near the northwest corner of the project site. Photo taken facing northwest.

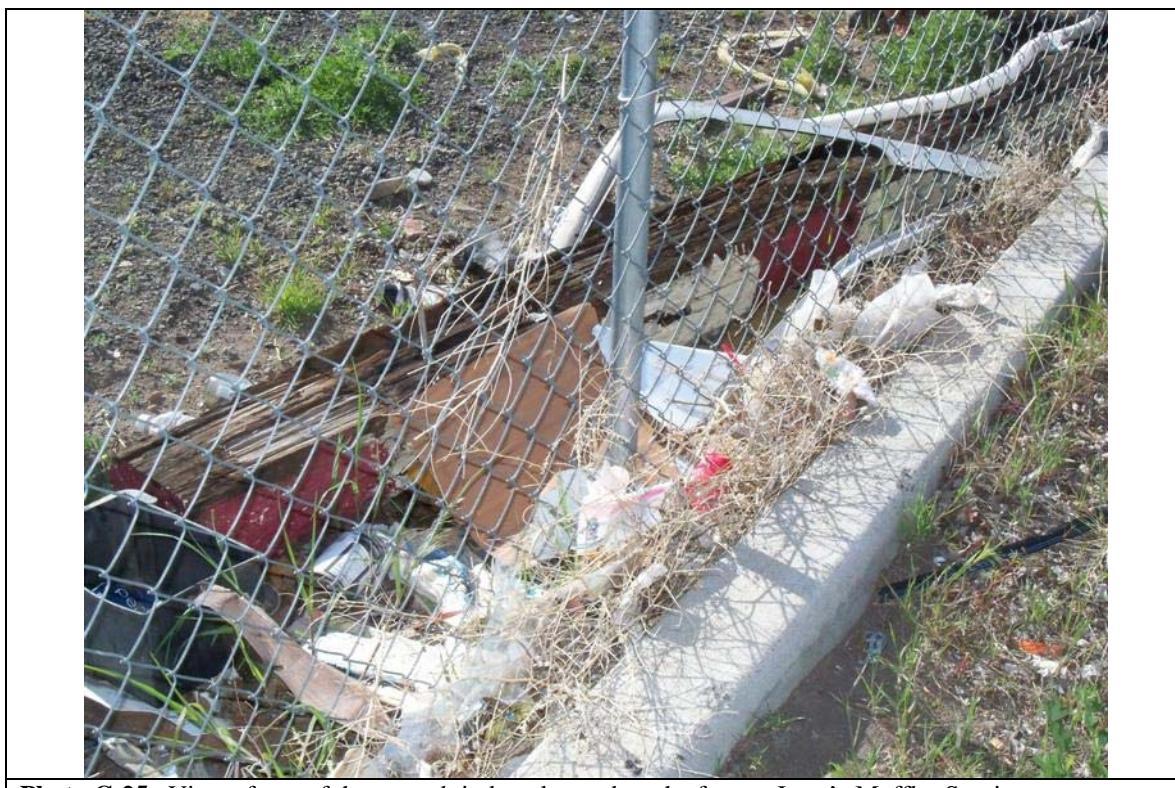
Creosote-treated timbers were observed at the former Jerry's Muffler Service property located adjacent east of the project site (Photo C-25). These timbers were located adjacent to the property line and were apparently used as parking barriers. These timbers are not considered to pose a risk to the project because they are not located within the project site.

Photo C-25. View of one of the treated timbers located on the former Jerry's Muffler Service property located adjacent east of the project site. Photo taken facing southeast.
